DEPARTMENT OF TRANSPORTATION

Quality Assurance and Source Inspection

Contract #: 04-0120F4Cty: SF/ALA Rte: 80 PM: 13.2/13.9File #: 1.28**WELDING INSPECTION REPORT****Resident Engineer:** Casey, William**Address:** 333 Burma Road**City:** Oakland, CA 94607**Report No:** WIR-027068**Date Inspected:** 20-Jan-2012**Project Name:** SAS Superstructure**OSM Arrival Time:** 700**Prime Contractor:** American Bridge/Fluor Enterprises, a JV**OSM Departure Time:** 1530**Contractor:** American Bridge/Fluor Enterprises, a JV**Location:** Job Site**CWI Name:** Salvador Merino**CWI Present:** Yes No**Inspected CWI report:** Yes No N/A**Rod Oven in Use:** Yes No N/A**Electrode to specification:** Yes No N/A**Weld Procedures Followed:** Yes No N/A**Qualified Welders:** Yes No N/A**Verified Joint Fit-up:** Yes No N/A**Approved Drawings:** Yes No N/A**Approved WPS:** Yes No N/A**Delayed / Cancelled:** Yes No N/A**Bridge No:** 34-0006**Component:** OBG Components**Summary of Items Observed:**

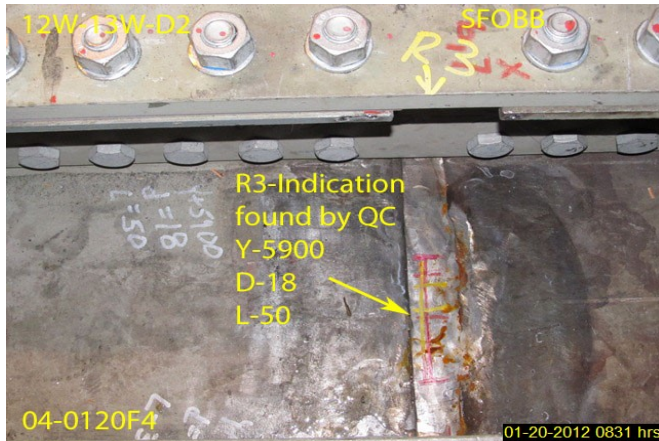
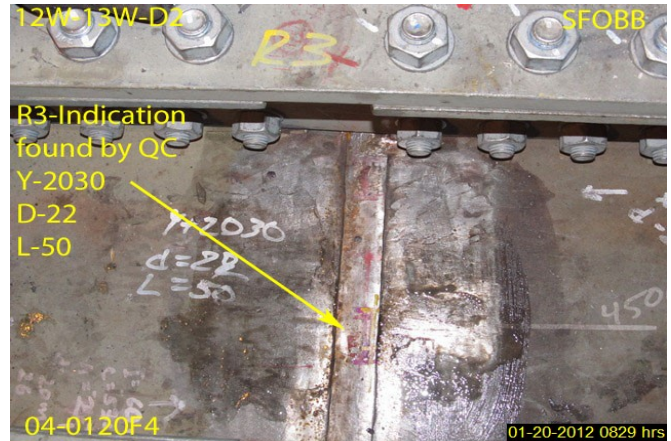
The QAI observed QC inspector Jessie Cayabyab had performed Ultrasonic Testing (UT) and discovered rejectable indications as outlined in AWS welding code D1.5. The dimensions discovered by QC were; location #1- Y-2030mm, depth-22 and length-50mm. Location #2 Y-5900mm, depth-18mm and length-50mm. Both

locations require a Critical Weld Repair (CWR) to be submitted to the Engineer for approval.

During a random observation it was noted that welder Fred Kaddu was performing the Shielded Metal Arc Welding (SMAW) using electrode E7018 under Welding Procedure Specification (WPS) ABF-WPS-D15-1001R for the Complete Joint Penetration weld repair in the flat (1G) position. The welder was observed at the 12W-13W-D1 (bottom plate) location on the interior of the OBG section performing these repairs. The locations were Y-760mm, depth-16mm, length-120mm and width-20mm. The electrode used during the repair was 3.2mm diameter with welding amps verified as 135. The welder was placing the intermediate weld passes for this location and using a power grinder and power wire wheel for the interpass cleaning. The QC inspector for this location was Salvador Merino and was observed verifying and documenting the welding parameters for this location, along with overseeing the welding operations. At the time of the observations no issues were noted by the QAI.
